5.3 Exterior Storefront and Entry Technical Guidelines

These technical guidelines apply to all properties that are considered historically significant in the Main Street Historic District

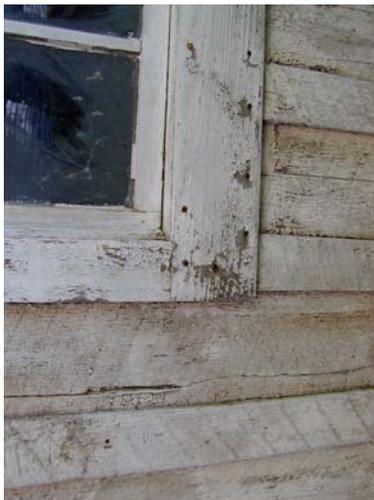
**MILDLY DETERIORATED
PAINTED SURFACE.**

- **Mild Deterioration:** Do the surface materials need repair? Is paint flaking? Are metal components rusting? Do joints need recaulking where materials meet glass windows? Mild deterioration generally requires only maintenance level treatments.

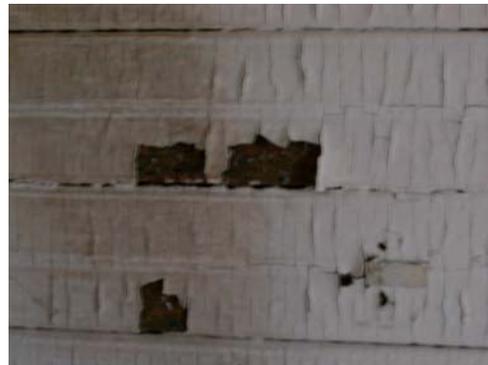
SEVERELY DETERIORATED PAINTED SURFACE ON WOOD DUE TO WEATHERING AND LACK OF MAINTENANCE.

Repainting Wood Storefronts: wood storefronts were historically painted to deter the harmful effects of weathering (moisture, ultraviolet rays from the sun, wind, etc.) as well as to define and accent architectural features. Repainting exterior woodwork is thus an inexpensive way to provide continued protection from weathering and to give a fresh appearance to the storefront.

As a general rule, removing paint from historic exterior woodwork should be avoided unless absolutely essential; see *Paint and Color Design Guidelines* chapter for information on paint removal and re-painting. Once conditions warranting removal have been identified, however, paint can be removed to the next sound layer using the gentlest method possible, then the woodwork repainted. For example, such conditions as mildewing, excessive chalking, or staining (from the oxidization of rusting nails or metal anchorage devices) generally require only thorough surface cleaning prior to repainting.

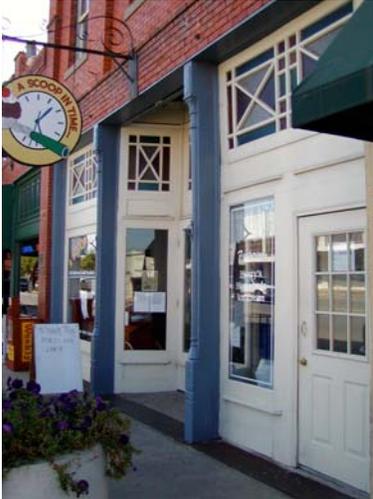
CAST IRON STOREFRONT

Cast iron storefronts are usually encrusted with layers of paint which need to be removed to restore crispness to the details. Where paint buildup and rust are not severe problems, handscraping and wire-brushing are viable cleaning methods. While it is necessary to remove all rust before repainting, it is not necessary to remove all paint.

For situations involving extensive paint buildup or corrosion, mechanical methods such as low-pressure gentle dry grit blasting (80-100 psi) are effective and economical, providing a good paint surface. This can be done on-site if precautions are taken re: contamination of the area.
